Re: September 2015 Monthly Progress Report

Gasco Sediments Site within the Portland Harbor Superfund Site

Attachment A Monthly Visual Monitoring Report for Pilot Cap Vicinity

# **Visual Observations Log Form**

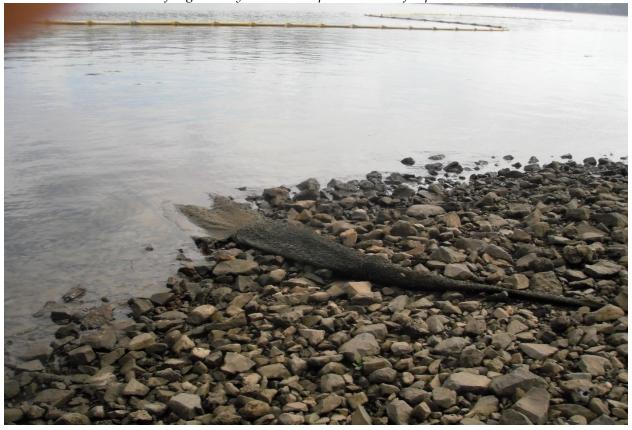
All previously noted organo-clay mat material segments are visible. A segment 5 feet in length is within 2-3 feet of the water's edge near the lateral mid-point of the cap area. A 6-foot section is shoreward of the water's edge located perpendicular to the shoreline at the upriver boundary of the cap (Photo 1). A section of organoclay mat material measuring 40 feet in length is exposed near the downriver extent of the cap at the water's edge and a 7 foot section is out of water.

Photo 1-V is ible section of organo-clay mat at the upriver extent of cap area (9/30/15):

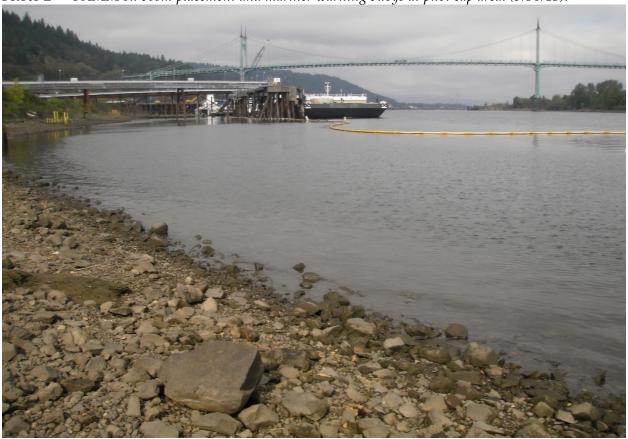
Observations of Long-term Controls (i.e., oil booms, organo-clay mat, etc.) During the observation, a barge was tied at the Fuel and Marine Marketing (FAMM) dock and the FAMM containment boom was placed across the cap area, from dock to dolphin. Two buoys that identify the cap area to mariners are in place as installed. The position of the FAMM oil boom, warning buoys, and a general overview of the site shoreline is shown in Photo 2.

Photo 2 - FAMM oil boom placement and mariner warning buoys at pilot cap area. (9/30/15):

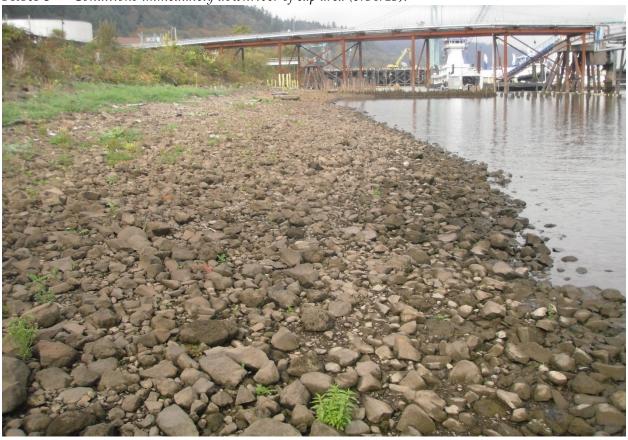
Other Comments:	No sheen is evident in or around the cap area. Photo 3 shows the water surface and shoreline immediately downriver of the sediment cap.

Photo 3-Conditions immediately downriver of cap area (9/30/15):
